COLD REGIONS RESEARCH AND ENGINEERING LAB HANOVER NH F/6 14/5  
INFRARED THERMOGRAPHY OF BUILDINGS: 1977 COAST GUARD SURVEY. (U)  
JUN 79 S J MARSHALL MIPR-7LB731-CO-206  
CRREL-SR-79-20 NL

4. TITLE (and Subtitle)  INFRARED THERMOGRAPHY OF BUILDINGS: 1977 COAST GUARD SURVEY		5. TYPE OF REPORT & PERIOD COVERED
		6. PERFORMING ORG. REPORT NUMBER

7. AUTHOR(s)  Stephen J. Marshall		8. CONTRACT OR GRANT NUMBER(s)
9. PERFORMING ORGANIZATION NAME AND ADDRESS U.S. Army Cold Regions Research and Engineering Laboratory Hanover, New Hampshire 03755		10. PROGRAM ELEMENT, PROJECT, TASK AREA & WORK UNIT NUMBERS U.S. Coast Guard Project MIPR 7LB731CO206

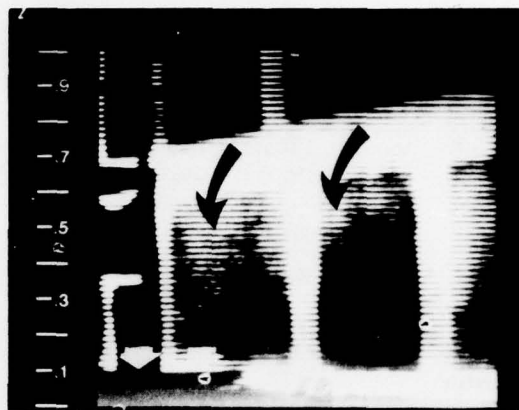
and vertical regular blocks outlining the split-ribbed sections are very warm. Note that the horizontal foundation is warm except where it is poured out around the cellar door (large black arrow, Fig. 9). The square split-ribbed panels to the right of the door have nonuniform patterns which are darker and colder near the bottoms of the panels, tapering off near the tops (arrows, Fig. 10). This suggests settling, missing or wet insulation near the top portions of the panels. Many areas on the three faces of the new section exhibited this effect.

Figure 10. Nonuniform thermal patterns on south face.

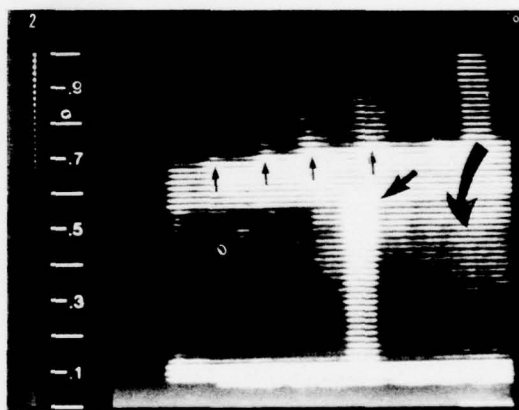
Figure 12 is a closeup of another group of east face split-ribbed panels showing the mottled pattern and the warmer areas near the tops of the panels. In addition, the bottom of the upper panel shows evenly spaced

Figure 12. Outlines of 2x4 studding on the east face.

anomalies that suggest spacings equal to the distance between internal 2x4 studding (small arrows, Fig. 12). Figures 13 and 14 are two more examples of the mottled pattern on the east and west faces of the new building. Figure 13 shows two large, circular, warm areas. In Figure 14 the vertical split-ribbed patterns can be made out on the thermogram as well as the outline of the normal blocks in the horizontal section above.

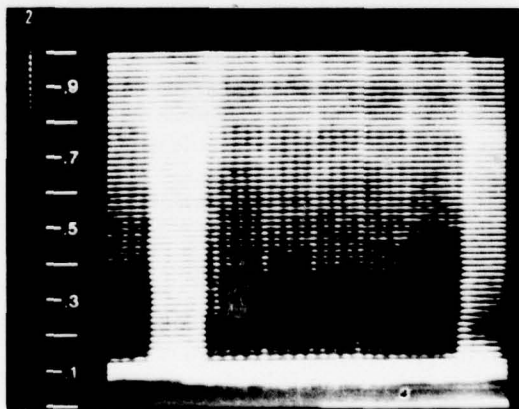
Figure 14. Nonuniform thermal patterns and block outlines on west face.

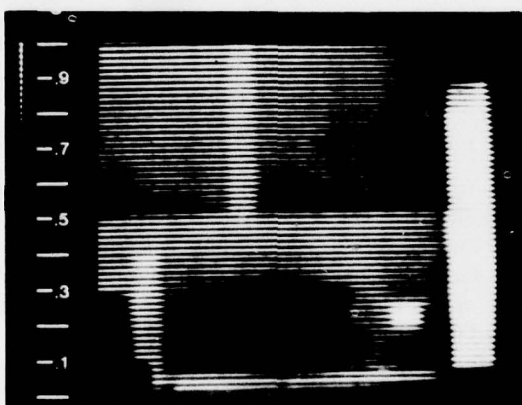
Figure 17. Comparison of cooler new section and warmer connecting section.

Figure 15 is a photograph of the east face of the new section with the east face of the glass connecting unit, and Figure 16 shows the east face of the old section. Figure 17, a thermogram of the east face of the new section, exhibits the familiar horizontal and vertical warm pattern separating split-ribbed panels. In addition, a small vent is visible in the lower right-hand corner. The glass interconnecting section at the right of the thermogram is much warmer than the new section face. The connecting section, at the left in Figure 18, is also much warmer than the old section. A cold and evidently well-insulated covered vent appears distinctly in Figure 18 but is hardly visible in the photograph. The blocked-in area where the old window opening was decreased in size to accommodate a smaller new window unit appears warmer than the face of the building itself (small arrows, Fig. 18). Figure 19 is a closeup of the east face of the glass connecting section. The hot vertical chimney appears cooler than the glass which surrounds it. These external chimneys waste a great deal more heat than chimneys constructed in the middle of a building. In this case the glass loses even more heat than the chimney, suggesting that this type of glass construction is not very energy efficient in cold weather.

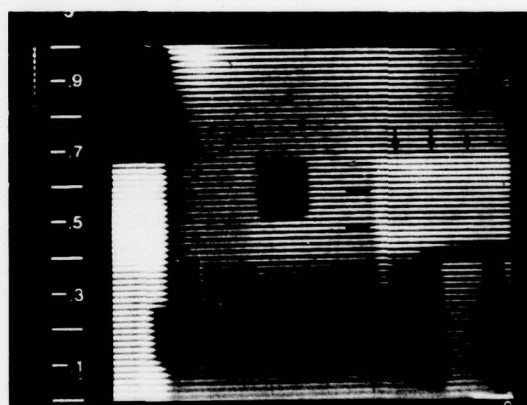
Figure 18. Covered vent and partially blocked window opening on east face.

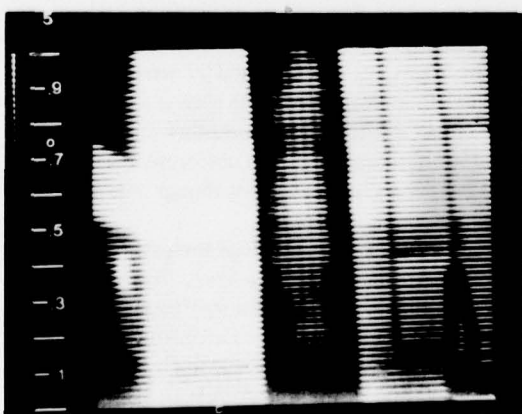
Figure 19. Glass connecting section and exterior chimney.

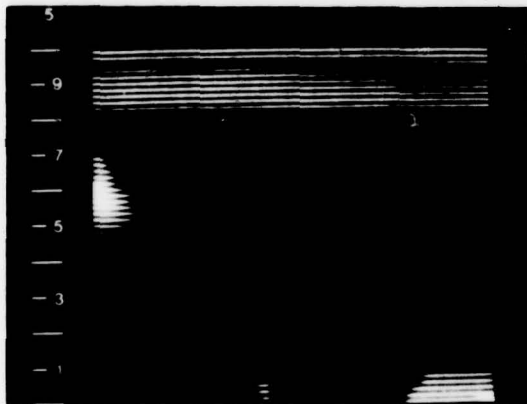
the south face, which reveals an excessive amount of heat loss through the glass transom and around the door. The door itself appears insulated. The concrete block walls appear uniformly insulated and in Figure 24 the actual outlines around each block can be recognized. The foundation is excessively warm, as are the concrete blocks immediately above the transom level and the horizontal precast beams above them.

Figure 24. Cool wall of south face.

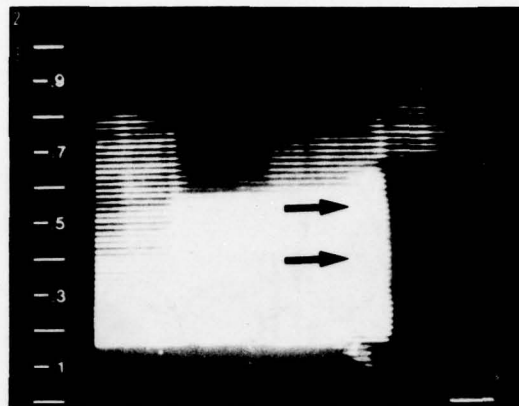
Figure 28 is a photograph of the east face of the building near the northeast corner. The object in the lower right-hand corner is the transformer, and the boiler room window is immediately to the left. Figure 29 is a thermogram of this area which shows the hot, left rear section of the transformer housing at midnight (arrows). All lights were out and personnel asleep at this hour, and so the station's electrical load was minimal. Several of the other stations also showed hot transformers (see for example, Fig. 46 and 59). Figure 29 also shows that the boiler room window is much warmer than the other windows. Since this room is

Figure 29. Boiler room window and transformer in northeast corner.

unoccupied, the window could be replaced with an insulated porcelain panel or other type of insulating unit.

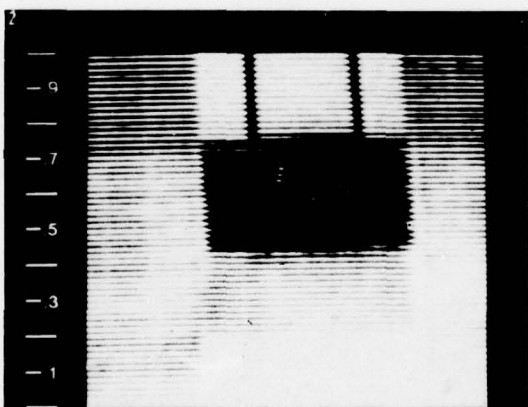
Figure 30. Thermal patterns in wooden panels separating first and second deck windows.

Figures 30 through 33 show thermograms of typical first- and second-deck window units separated by what appear to be underinsulated wooden panels. Figures 30 and 31 show that the upper panels in both cases are cooler than the lower panels, and that an indistinct pattern appears in the center of each upper panel — apparently the outline of the room heaters and vertical 2x4 studs.

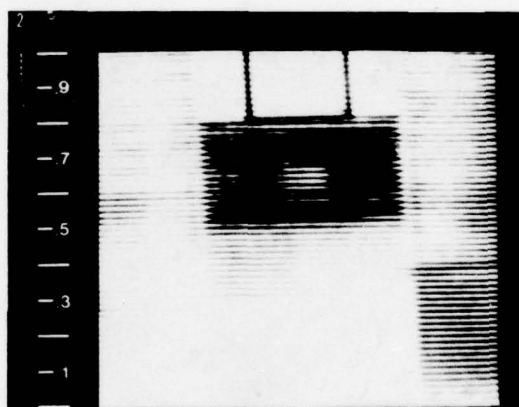
Figure 31. Radiator and 2x4 outlines under second deck window.

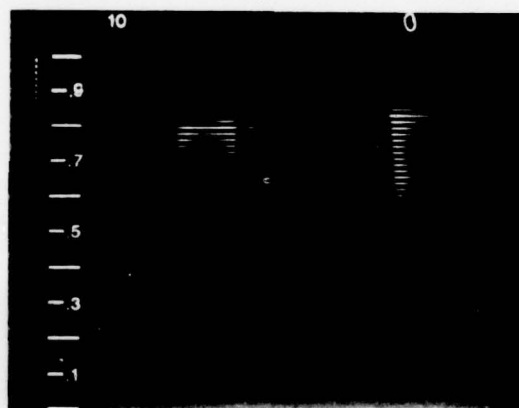
confirmed by a closeup shot in Figure 38 of the north face window. Infiltration patterns on the glass can clearly be seen vertically along the left and right-hand glass/meeting rail interface. There is also leakage along the top horizontal window frame/brick interface.

Figure 38. Closeup of communications center window on north face.

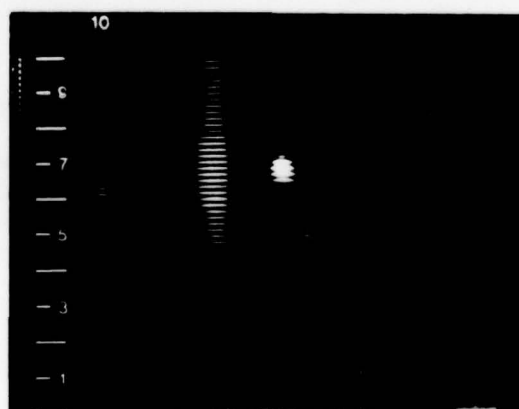
Figure 40 is a thermogram of the north face of the stairwell which is just to the right and out of view in Figure 35. The narrow vertical pattern is the warm window glass extending from the foundation to the tower of the stairwell. The thermogram indicates that the stairwell is excessively warm, and since it is not heated, it must be robbing heat from the building (chimney effect). Perhaps these vertical windows should be replaced with insulated panels on the north face to conserve energy. The door is indicated on the thermogram immediately to the right of the glass pattern as the horizontal and vertical patterns below the circular pattern which is the light above the door. It indicates that the door leaks at its top interface but not as badly as many other stairwell doors at other stations.

Figure 40. Warm vertical window on north face of unheated stairwell.

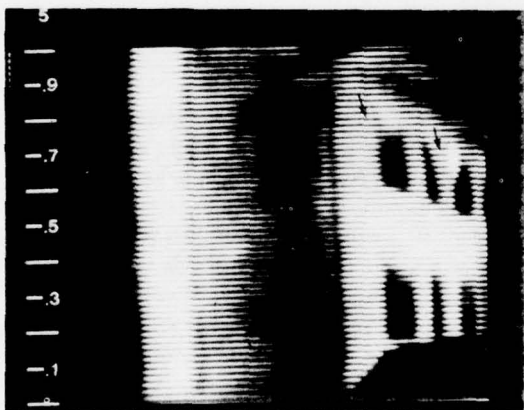
Figure 43. Solar effect on southwest corner.

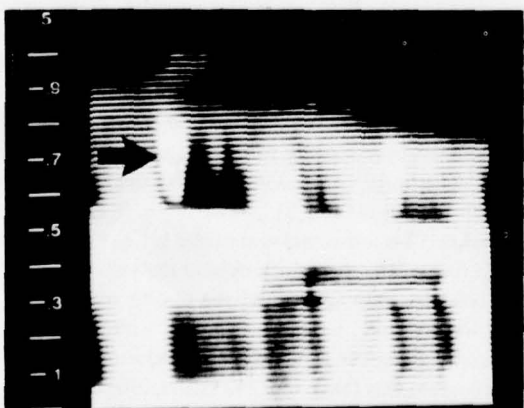
Figure 45. Second deck window exfiltration in spite of drawn drapes.

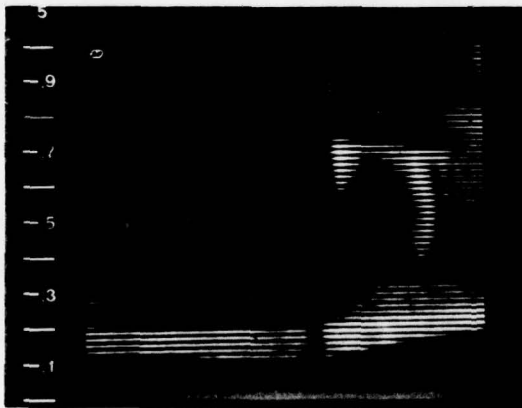
Figure 50. Communications center windows.

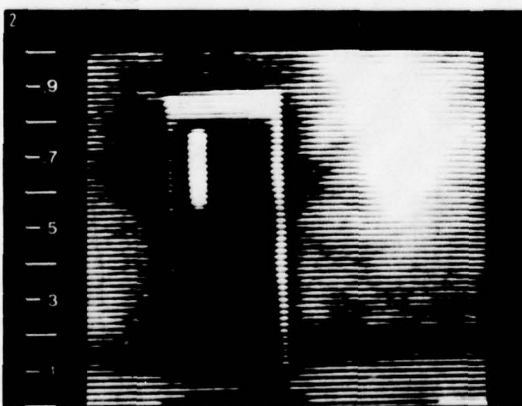
Figure 52 is a thermogram of the galley door on the south face of the mess deck behind the jeep in Figure 48. Note that the light above the door is off and the light fixture cold. Leakage is evident around the door, especially along the top and right-hand interfaces. This thermogram was taken at 2249 hours, long after the galley equipment had ceased operation, although this door is used frequently by station personnel at night.

Figure 52. Galley door on south face of mess deck.

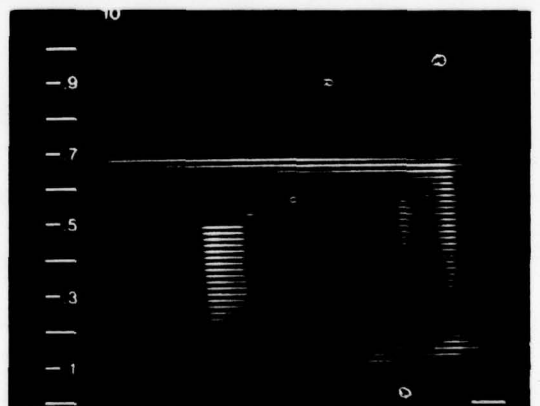
Figure 53. East face of mess deck.

Figure 53 is a thermogram of the glass door in the east face of the mess deck which is nominally at the same inside temperature as the galley. However, this thermogram, taken at scale 10, shows that the windows on either side of the door, which all open into the same room, are much more energy efficient. The light above this door is also turned off.

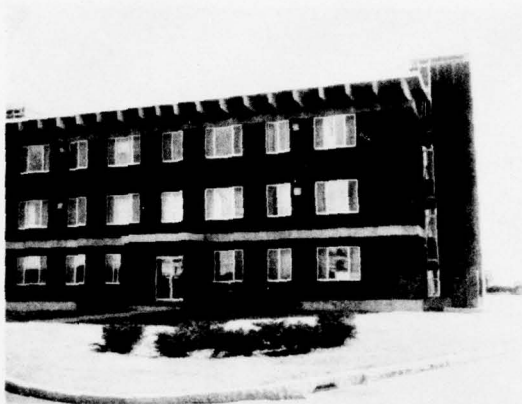
Figure 54. West section of north face of Gloucester station.

Figure 54 is a photograph of the north face, west section of the Gloucester Station. Figure 55 is a thermogram of a vent to the right of the second deck bathroom window. The plume of hot air from the vent is blowing down and to the right or west even though the wind was from the south-southwest at 18 knots.

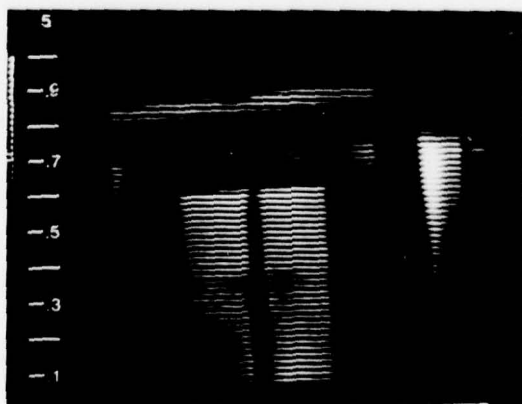
Figure 58. Boiler room window to right of main entrance door.

Figure 58 is of the glass main entrance door, which displays some heat loss at scale 5, despite a closed vestibule inside. Of more concern, however, is the exceedingly warm window immediately to the right of the main entrance. Windows of the unoccupied boiler room could be replaced with insulated panels to conserve energy. In Gloucester Station's case, the boiler was not providing sufficient heat for the building

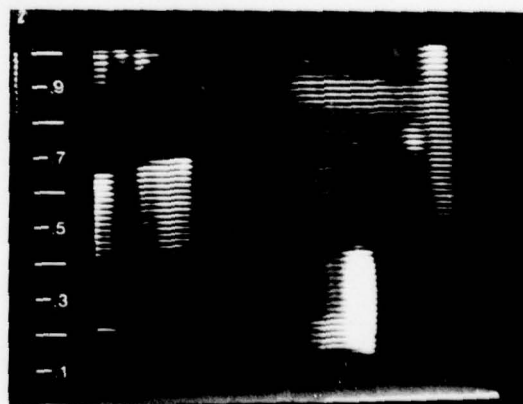
Figure 59. Hot transformer at 2316 hours.

and so most of the personnel had electric heaters in their rooms. The tremendous electrical load at 2316 hours is illustrated in Figure 59 by the hot transformer in the lower right corner of the thermogram, which corresponds to the lower right of the Figure 54 photograph. The vertical stairwell windows and the horizontal second floor can also be seen behind the transformer.

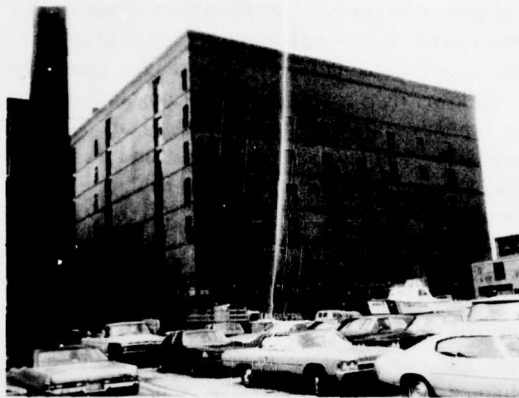
Figure 61. Northeast corner of recently renovated building 8.

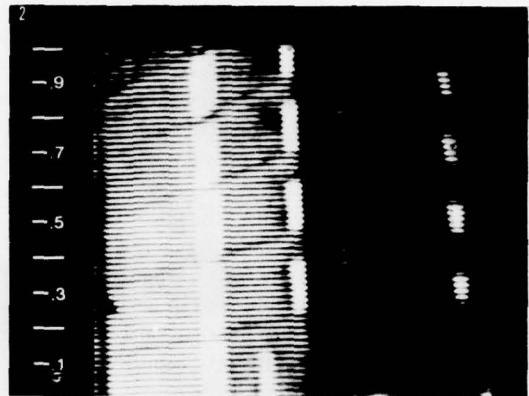
Figure 62. East face of building 8 on left and north face on right.

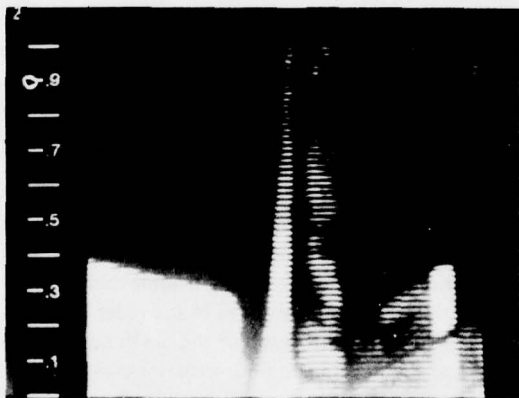
Figure 63. Building 4 on left appears warmer than building 8 on right.

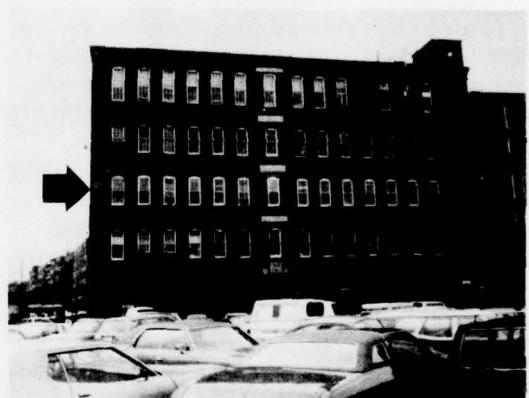
Figure 64 is a photograph of the north face of building 4, and Figures 65 and 66 are thermograms of the

Figure 64. North face of building 4. Arrow points to new windows.

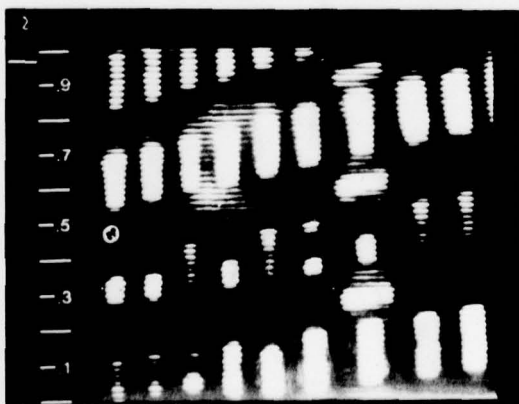
Figure 65. Thermal outlines of new windows and original windows.

north face. In addition to the somewhat obvious heat loss patterns due to open windows and/or storm windows, Figures 65 and 66 show the comparison between some new windows on the third deck and the original windows. In Figure 65 the second horizontal row from the bottom consists of new windows, and the warm rectangular area of each window is of smaller area than that of the old windows, although all windows are the same size. Also several of the windows have dark cool patterns which indicate how well the storm windows would work if kept closed. The warm granite stones between the vertical stairwell windows can be seen to the right of center in Figure 65. The third horizontal row in Figure 66 is of the third-deck windows to the right of the stairwell. In Figure 65, the fourth-deck windows to the left of the stairwell exhibit a large circular warm pattern on the brick. This type of typical pattern showed up on many of the faces of all the older buildings and indicates heat loss problems in the brick walls themselves.

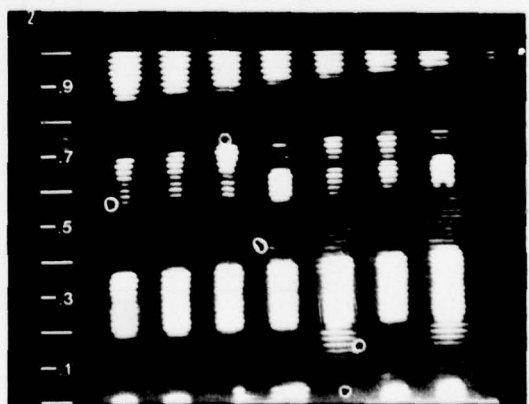
Figure 66. Thermal patterns of some of the new windows.

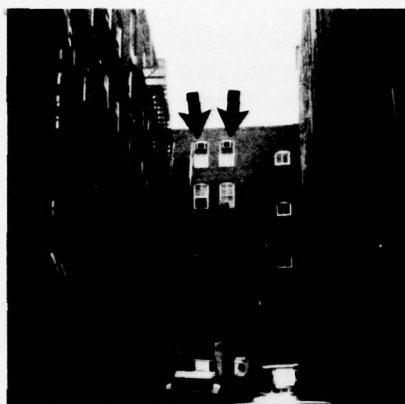
Figure 67. Arrows indicate air conditioner units on north face of building 1.

Figure 67 is a photograph of the north face of building 1 taken from the passageway between buildings 2 and 4. Note the two air conditioner units in the windows on the top deck. Figure 68 is a thermogram of these two windows. It shows how the windows themselves and the air conditioner units are dark or cool but the area to the left and right of each air conditioner leaks badly. The brick wall exhibits a cool pattern along the top deck but a warm pattern along the deck below it.

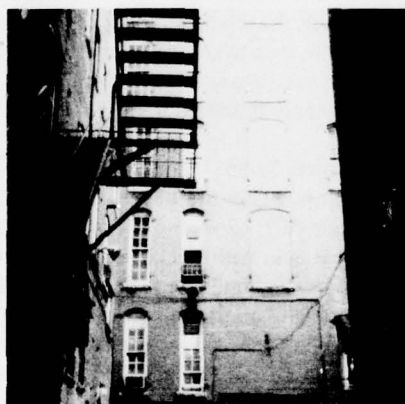
Figure 69. Bricked-in windows on east face of building 4.

Figure 69 is a photograph of the east wall of building 4 taken from the passageway between building 1 and building 2. The corresponding thermogram, Figure 70, shows how one of the bricked-over windows is

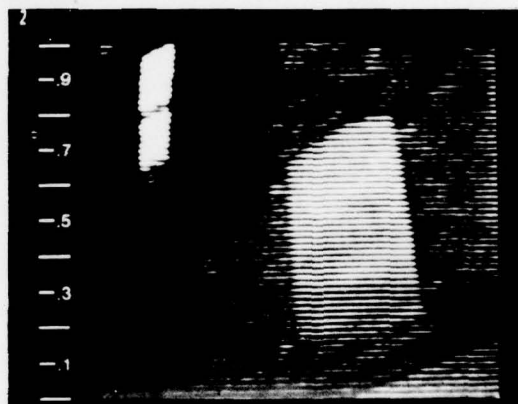
Figure 70. Bricked-in window and surrounding brick wall.

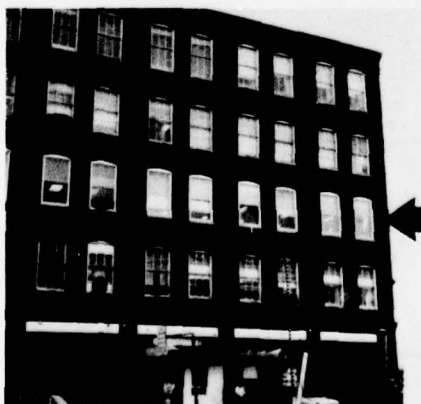
Figure 71. Upper decks on east face of building 3.

Figure 71 is a photograph of the north section of the east face of building 3. The new windows on the third deck (black arrow) exhibited the same improved thermal patterns as those on the north face in Figures 65 and 66. Figure 72 is a thermogram of some fourth and fifth deck windows. This and other thermograms of the rest of the fourth and fifth decks show that these top two decks were very much warmer (scale 20) than the lower ones. It has been our experience that buildings exhibiting extremely warm top decks and much cooler lower ones, together with numerous open windows in the winter, have a very serious temperature regulation problem. Invariably we find that only one single zone thermostat controls the whole building. Corrections to the heating system, such as using multiple zones, must be undertaken in addition to installing energy efficient windows and properly insulated walls.

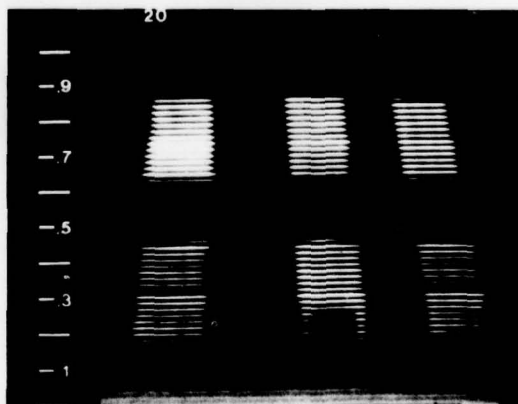
Figure 72. Extremely warm top deck windows on east face of building 3.

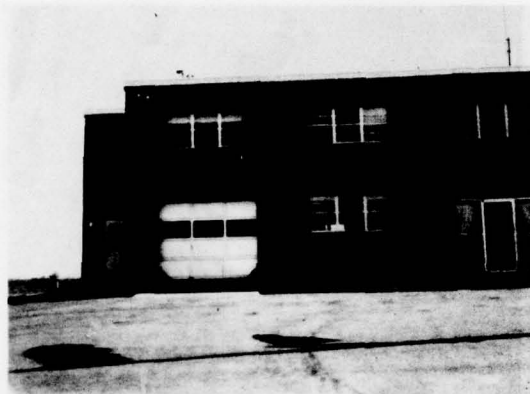
The Portsmouth Harbor Station (Fig. 73) in New Castle, New Hampshire, consists of a 35x12-m concrete masonry barracks with brick exterior built in 1967, a 18x9-m reserve building with brick exterior, and a motor pool with concrete block exterior. Figure 74 is a photograph of the east section of the north face of the two deck barracks and Figure 75 is the west section of the north face. Figure 76, a thermogram of the east section of the north face, shows a badly sprung stairwell door, a garage door with excessive leakage

Figure 74. East section of north face of Portsmouth Harbor station.

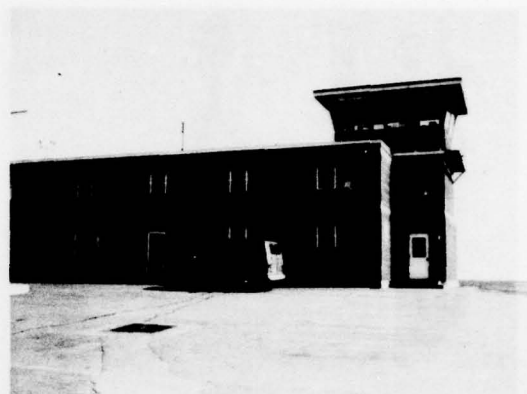
Figure 75. West section of north face of Portsmouth Harbor station.

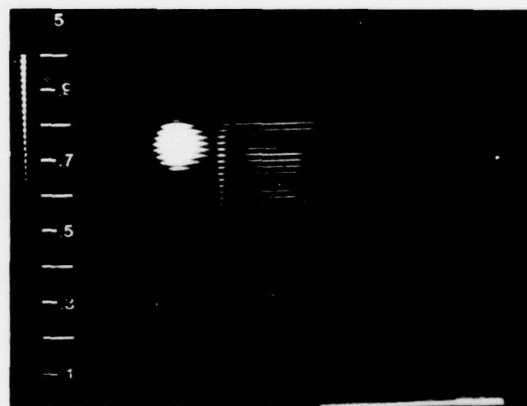
Figure 77. Badly sprung stairwell door on northeast corner of building.

Figures 77-79 are closeups of the stairwell door, garage door, and window, respectively. Figure 77 is a confirmed example of what a badly sprung metal door, i.e. a door bent by the strong winds, looks like in a thermogram. The upper horizontal and vertical interfaces show a wide thermal heat loss pattern where as there is little leakage along the bottom interface. This could result from the bottom interface experiencing infiltration of cold air while the top interface is allowing exfiltration of warm air. Other stations subjected to the same high winds (Boothbay Harbor and Jonesport) had doors with similar patterns.

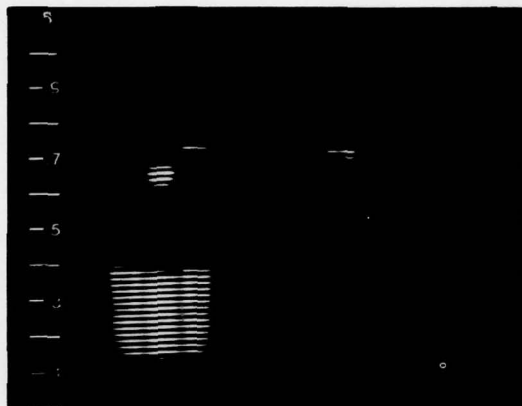
Figure 80. Comparison: entrance on right with vestibule, and entrance on left without vestibule.

In Figure 80 (a thermogram of the west section of the north face) other window heat loss problems can be noticed and the faint outlines of heaters under the windows are evident. In addition, the two all-glass doors are compared thermographically. The one on the left, for the Teletype Repair Office, is warmer than the main entrance on the right which has an enclosed vestibule. Figure 81 is a closeup thermogram of the glass teletype repair door which uses the camera's isotherm function. The irregularly shaped sinusoidal isothermal patterns on the glass are typical of isothermal patterns observed on windows and doors that have heat loss problems. It is suspected that these patterns

are related to the amount of infiltration, where it is taking place, and whether it is infiltration or exfiltration. Further research needs to be done in order to learn the cause of these interesting patterns.

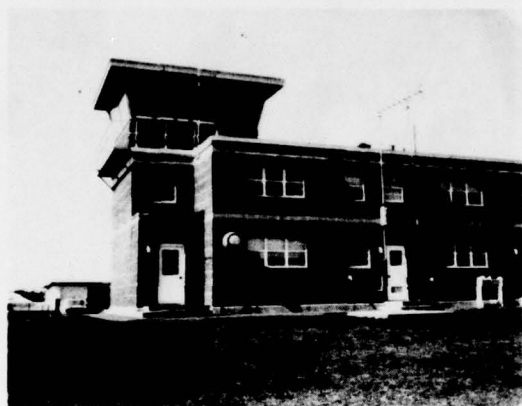
Figure 82. Southwest section of south face of Portsmouth Harbor station.

Figure 82 is a photograph of the west section of the south face of the barracks and Figure 83 is a thermogram of the west face (extreme left in Fig. 82), the right-hand section being the stairwell under the tower. The west face of the barracks stairwell exhibited a mottled pattern but the west face of the left-hand portion (where the mess area is located) did not. The round spot on the wall is a sign. For some reason, this station had a mottled pattern only on a portion of the west face which is minimal in size compared to moisture patterns at some of the other stations.

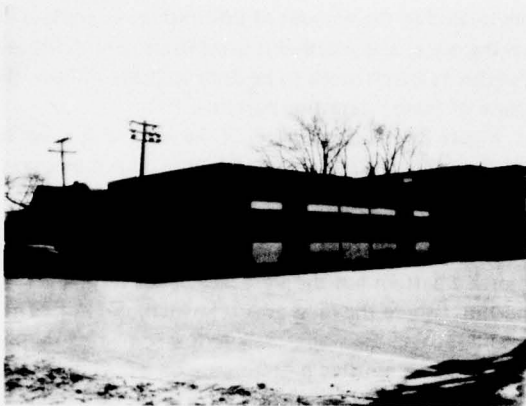
Figure 87. Northeast corner of mess deck of building 6 at Portland Base.

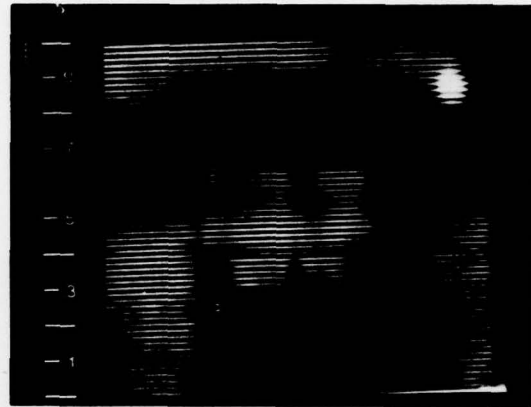
Figure 88. Window on north face with insulated porcelain panels.

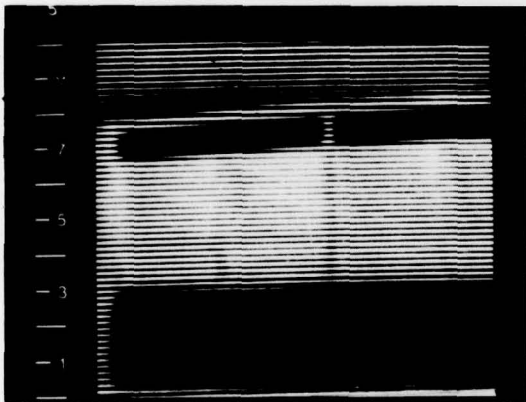
Figure 89. Panels above and below the glass appear cool.

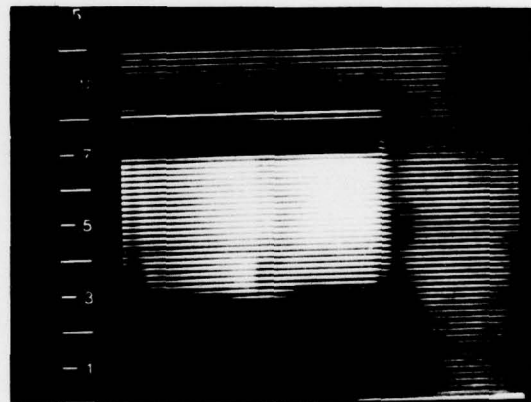
Figure 90. Interfaces around panels.

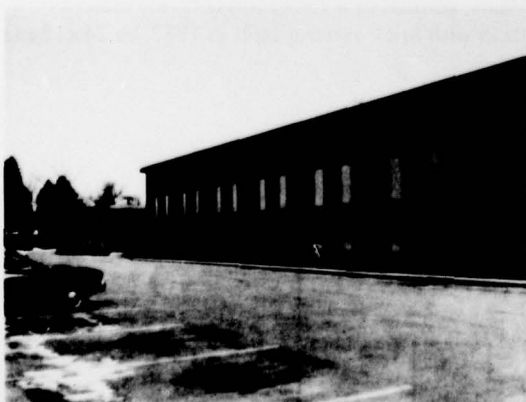
Figure 91. North face of two deck barracks section of building 6.

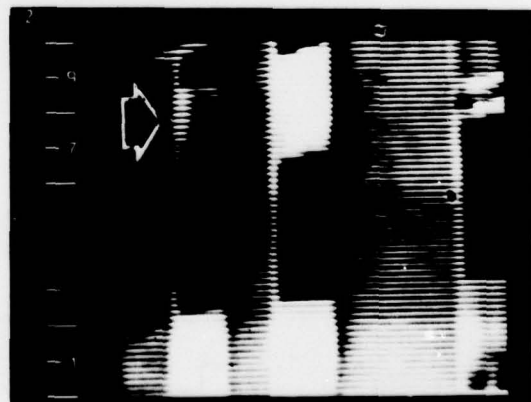
Figure 92. Thermal pattern on second deck window (arrow).

Four types of window patterns are evident in Figures 92-94 and 97. Most of the windows are uniformly white but two are almost black, as seen in the right-hand window in Figure 94 and the right-hand upper window in Figure 97. The left-hand upper window in Figure 92 (arrow) shows a dark vertical pattern in the middle with a white pattern at the vertical edges, while the upper left window in Figure 93 (arrow) shows the reverse. What these patterns mean is not clear; it could be the effect of drawn drapes, opened lower portions of the windows, or room heaters that were turned off. In any event it seems clear from the even rectangular patterns of the windows and panels at scale 2 that this type of construction is vastly superior for energy conservation in cold regions to that of other stations.

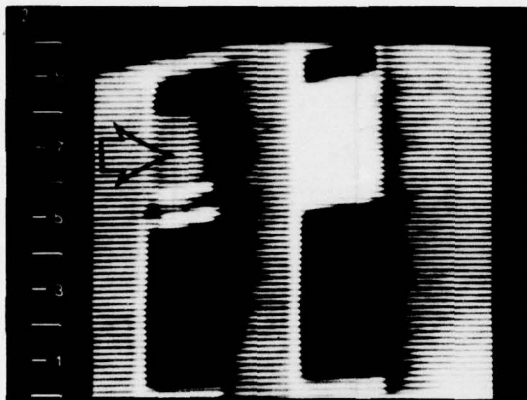
Figure 93. Second deck window opened, lower section.

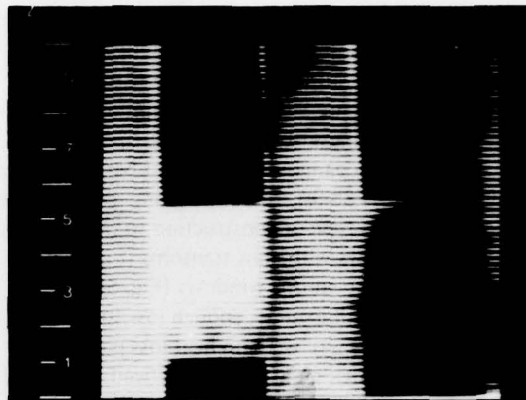
Figure 94. Cool porcelain panels, note cool window on right.

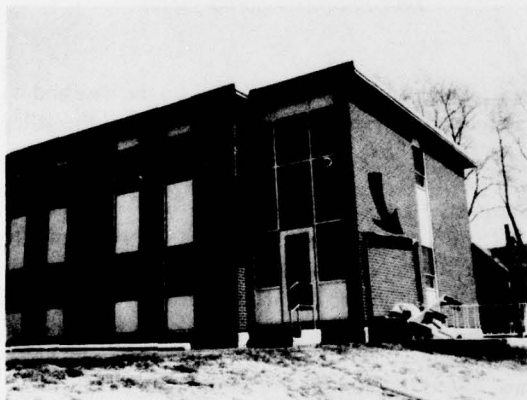
Figure 95. Northwest corner of two-deck barracks section of building 6.

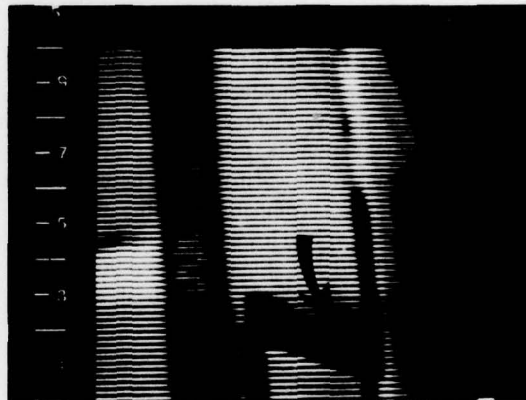
Figure 96. Porcelain panel between first and second deck windows.

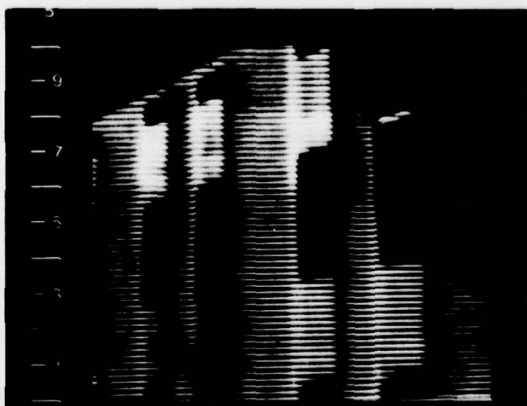
Figure 97. Cool porcelain panels, note cool window on upper right.

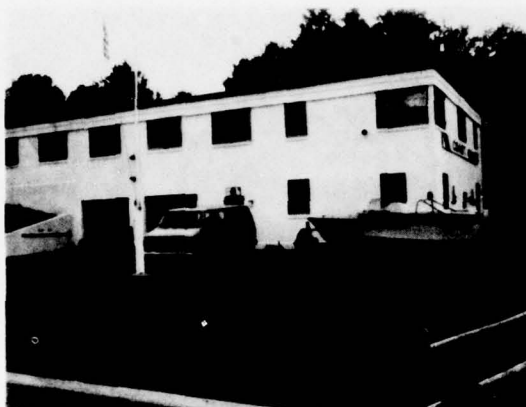
The Boothbay Harbor Station (Fig. 99) in Boothbay Harbor, Maine, consists of a 29x12-m concrete masonry barracks built in 1967, and a wooden 13x9-m duplex. Figure 100 is a photograph of the northeast corner of the Boothbay Harbor Station. The major source of heat loss at this station is radiator leakage under the windows, an example of which is shown in Figure 101, a thermogram of the three second-deck windows on the left in the photograph. Figures 102 and 103 also show radiator leakage under the windows in addition to other artifacts, as was true for all four faces of the building. This could be easily rectified by station personnel, themselves, fabricating aluminum reflectors and installing them between the radiators and the inside walls. This was done successfully at Dartmouth College where thermographic detection of radiator heat loss through walls was first noticed.<sup>6</sup>

Figure 100. Northeast corner of Boothbay Harbor Station.

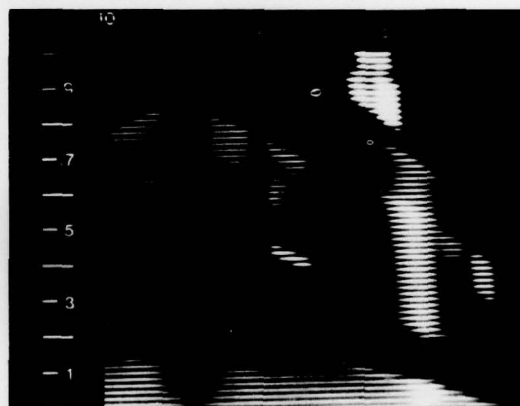
Figure 103. Vertical thermal pattern from chimney.

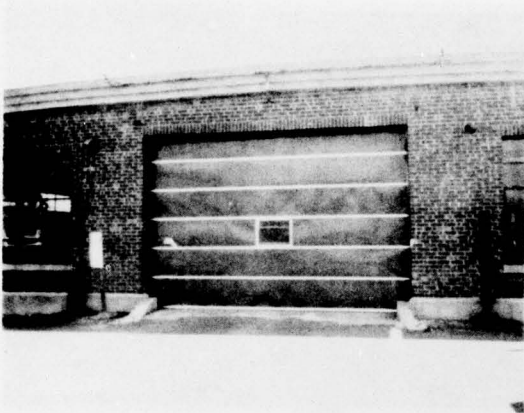
Figure 106. Insulated fiberglass overhead door at New Hampshire Highway Garage.

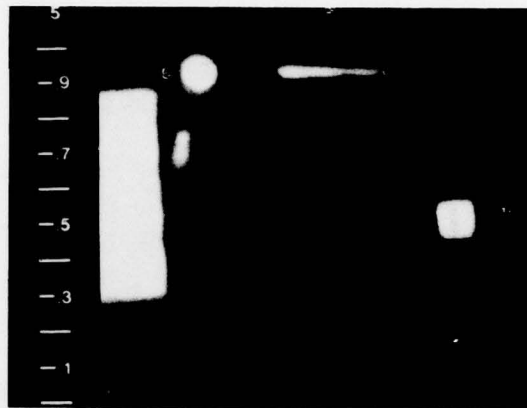
Figure 107. Thermogram of insulated fiberglass door.

be vastly superior to most was an insulated fiberglass door installed on the north face of the New Hampshire Highway Garage\* in Concord, New Hampshire.<sup>8</sup> Figure 106 is a photograph of the door and Figure 107 is a thermogram of that door. This thermogram shows an almost completely black pattern, except for the small single window area and the top horizontal interface, which is probably due to the constant daily use that this door experiences. For orientation purposes, the white rectangular white area on the left of Figure 107 is the window on the left in Figure 106.

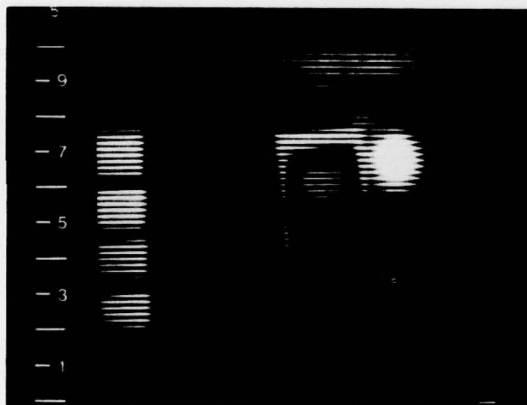
Figure 108. Closeup of overhead door and boat crew door on east face.

Figure 108 is a closeup thermogram of the door to the right of the overhead garage doors in the east face. It shows the typical thermal pattern of a sprung door recognized and confirmed in Figure 78 and evident at a majority of the stations. This particular door gets very heavy usage as it is the passageway from the communications center to the boat dock used by the boat crews.

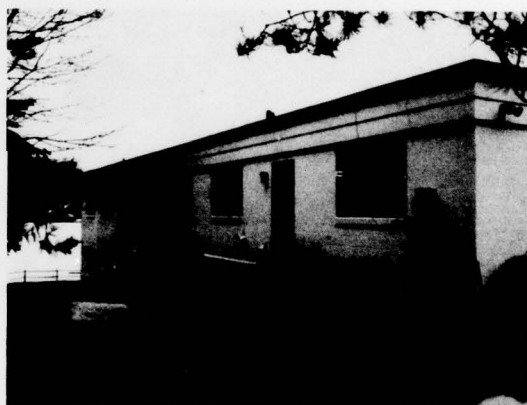
Figure 109. West face of Boothbay Harbor station.

Figure 109 is the galley door on the west face of the building which is never used except as an emergency exit. Figures 110 and 111 show how tight and thermally sound the door is. Figure 110 also shows that the window immediately to the left of this door does not have a radiator pattern under it — only because there is no radiator under this galley window.

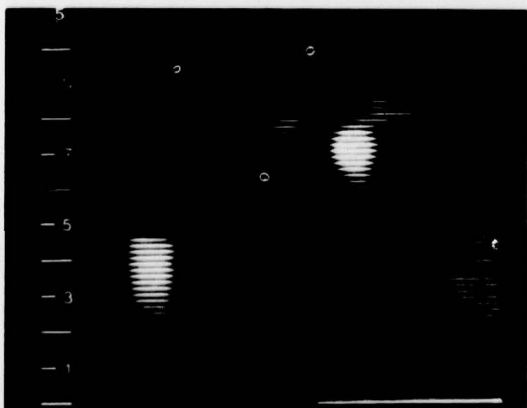
Figure 110. Rarely used galley door on west face.

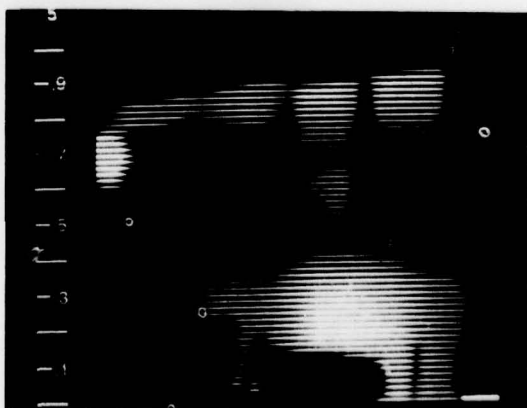
Figure 111. Radiator under window radiates through wall on west face.

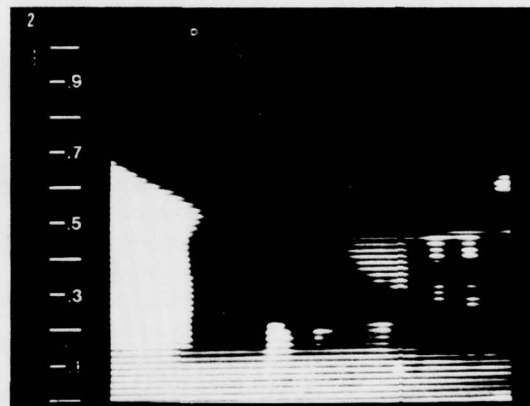
Figure 122. Brick building on left and wooden building on right.

Figure 122 is a thermogram that compares the temperature of the east face of the brick Administration Building with the south face of the wooden supply building. The brick building is much warmer and the wooden building does not display the solar thermal effects, indicating that wooden buildings cool off much more quickly than brick buildings.

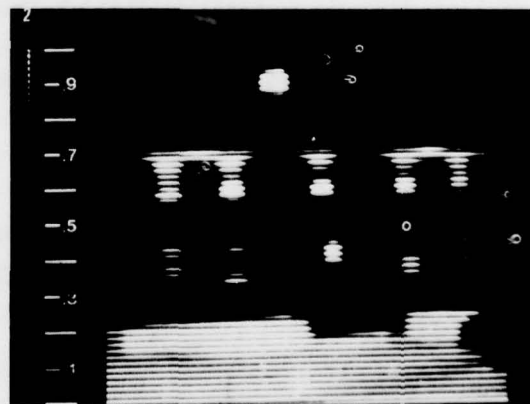
Figure 124. Thermogram of wooden building.

Figure 123 is a photograph of the southwest corner of the wooden supply building, an old barracks built in the 1940's. The blueprints show 7.5 cm of blanket insulation in the stud bays and in the ceiling. Figure 124 is a thermogram of the south face and shows leakage typical of all the wooden buildings surveyed at the various stations. The foundation is very warm, and the warmth in the eaves indicates inadequate insulation in the attic. Numerous closeups of any portion of the stud bays show cool bays and warm studs, indicating that insulation is present. It can also be seen that the warm chimney is at the center of the building, the radiators do not show through the walls, and the front entrance has an enclosed vestibule. These features show that architects in the 40's were more committed to energy conservation in buildings than many seem to be today.

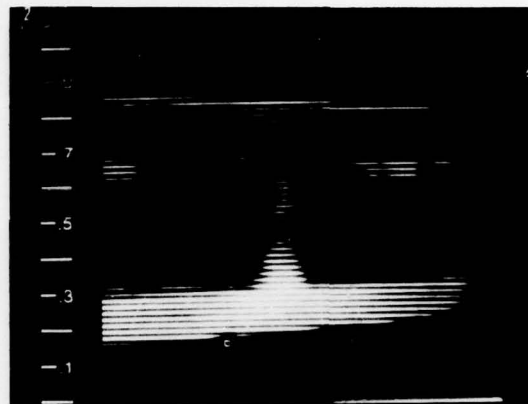
Figure 127. Mess deck windows on south face.

brick exterior built in 1969, a 15x10-m wooden duplex, a motor pool with brick exterior, a heated boathouse with brick exterior, and several single-story housing units. Figure 126 is a photograph of the east face of the Jonesport Station mess deck and Figure 127 is a thermogram of the south face windows of the mess deck. These windows are of the horizontally sliding aluminum type, and they exhibit leakage along the vertical meeting rails and along the top horizontal interface. Figure 128 is a thermogram of the window unit on the east face of the mess deck which was sprung by the wind and which leaks quite badly whenever there is wind-driven rain from this direction. The thermogram of this window in Figure 128 shows that the first vertical meeting rail from the right is in poor condition and the top horizontal interface leaks badly.

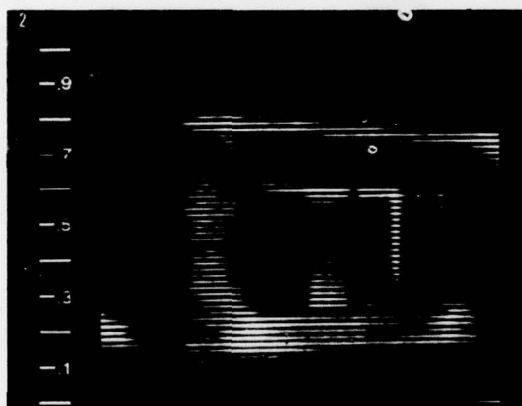
Figure 128. Badly sprung window unit on east face of mess deck.

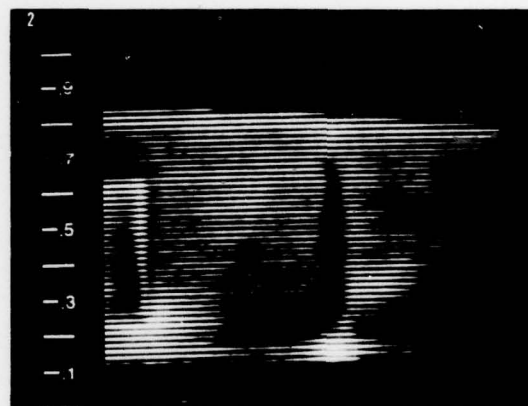
Figure 129. Cool foundation on east face of mess deck.

Figure 129 is a thermogram of the wall to the right of this window, which shows (along with Fig. 128) that the floor slab at this station is cooler than the wall — the opposite of conditions at most of the stations. The dark vertical stripe shown in Figure 129 is a cavity containing pipes to the dishwasher in the galley.

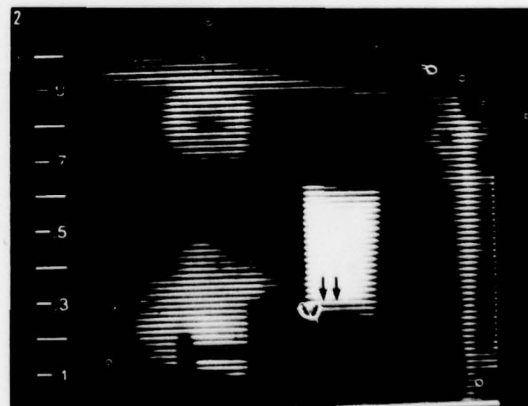
Figure 131. Galley door on the northwest face.

Figure 130 is a photograph of the north face of the galley, the connecting section, and the east section of the two-deck barracks. Figure 131 is a closeup thermogram of the galley door located in the northwest section of the galley. In addition to the noticeable leakage through the glass panel in the door, the vertical ribs in the lower portion of the doors can be seen (small arrows). The upper left-hand pattern is a vent, the metal portion of which is cool but the area around it is warm. The warm pattern in the lower left wall area is coming from a small locked room to the left of the door that contains a freezer. The warm vertical construction joint interface with the connecting section can be seen at the right-hand edge of the thermogram.

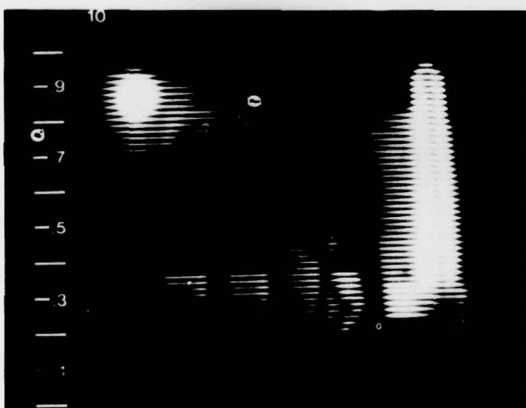
Figure 134. Chimney that is warmer than glass window transoms.

Figure 133 is a photograph of the west section of the north face of the two-story barracks. Figures 134, 135, 136 and 137 are thermograms of selected portions of this north face which do not exhibit the familiar radiator leakage under the windows. All the windows are closed, demonstrating that this station has six heating zones each separately controlled and comfortably

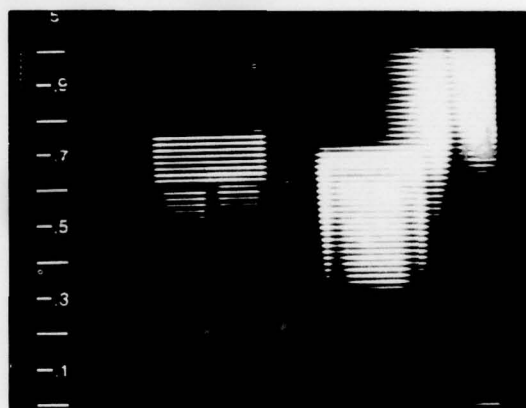
Figure 135. Exfiltration around upper half of door.
